» Seam Assessment and Regulatory Compliance: Multiple Datasets + EMAT

T.D. Williamson

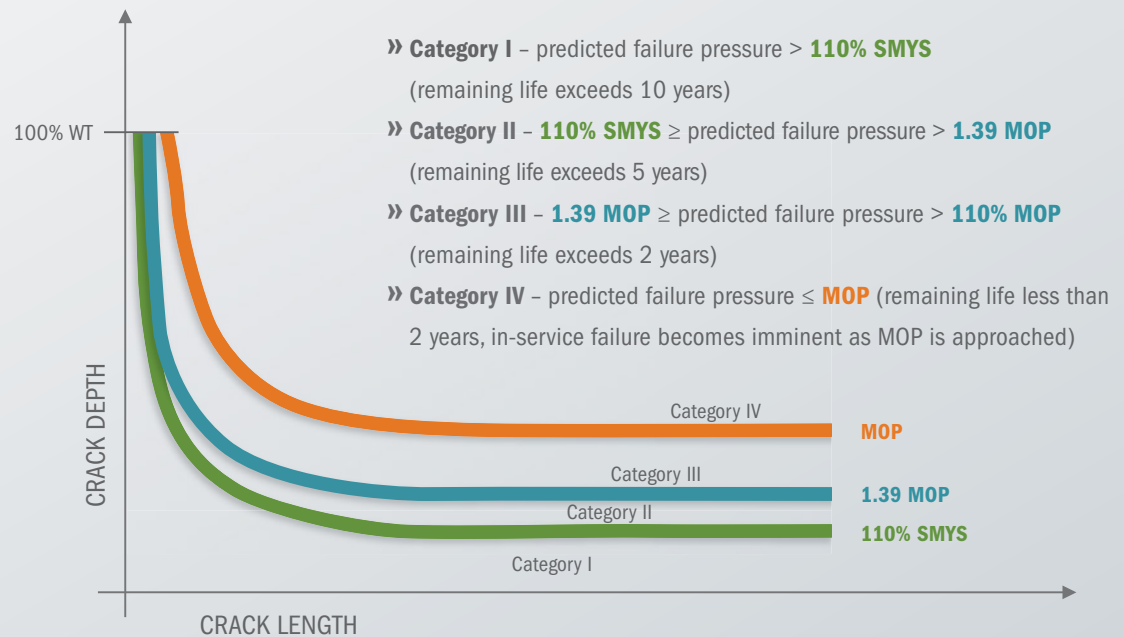
Once the ILI results were validated through NDE, the operator was able to use the data to prioritize repairs. The analysis showed that the pipeline could continue to operate at MOP for another 10 years before the remaining cracks would cause critical failure. Using American Society of Mechanical Engineers (ASME) B31.8S and the Modified Log-Sec model to predict failure pressure, the operator analyzed and categorized the remaining crack and crack-like anomalies in the pipeline. These categories are shown in the graph below.

The operator concluded that all cracks and crack-like anomalies not repaired in the pipeline were reported in the Category 1 region (i.e., would be graphed below the green line).
