CaseStudy

LPG Terminal in Coari-Urucu / Amazonas, Brazil

Hot Tapping and STOPPLE®

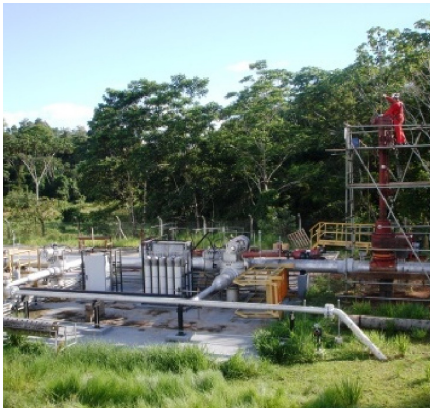
Remote Amazonian LPG terminal needs valve repair.

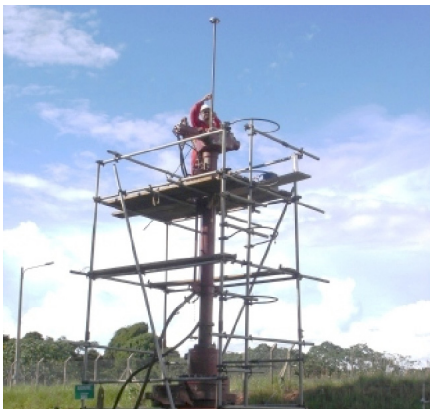
TDW Hot Tapping & Plugging Services enables repairs without environmental damage.

Hot Tapping and STOPPLE® equipment was used to plug the pipeline near the launcher and receiver to stop gas flow. Two STOPPLE plugging operations performed in severely hot and humid Amazon Jungle weather allowed TDW Brazil to guarantee the isolation of the launcher and receiver. Working on his own, the contractor would not have been able to make necessary repairs within the 36-hour timeframe. TDW Brazil plugging service was crucial for the success of the operation. The line stops remained in place for 30 hours after which both plugging heads were removed. This was the first opportunity for TDW to perform services in this remote part of the country.
